# STPUD tested as it keeps water flowing during fire

Angora Fire --  
5 years later

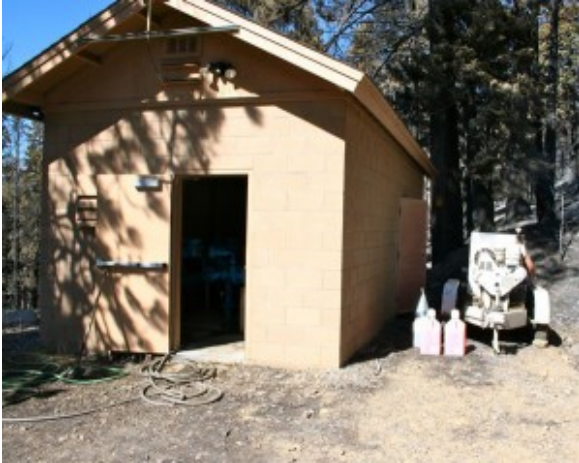
The fire nearly consumed the STPUD pump and control building at Boulder Mountain.

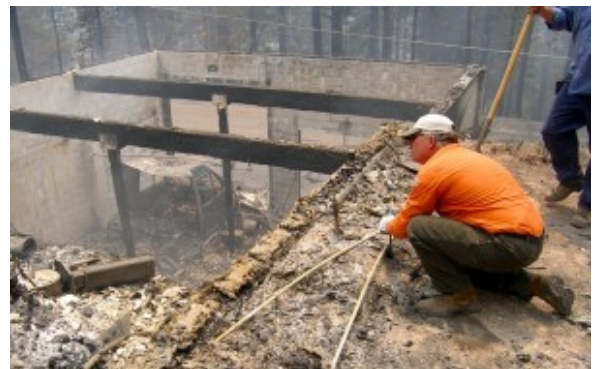
District crews crimp water supply lines in the burn area.

that by 254 and it becomes very significant. District crews immediately began to shut off water services that could be quickly located and crimp off those that could not be readily located.
